MILES POND DAM
VT 00062

PHASE I INSPECTION REPORT
NATIONAL DAM INSPECTION PROGRAM

DEPARTMENT OF THE ARMY
NEW ENGLAND DIVISION, CORPS OF ENGINEERS
WALTHAM, MASS. 02154

DECEMBER 1980

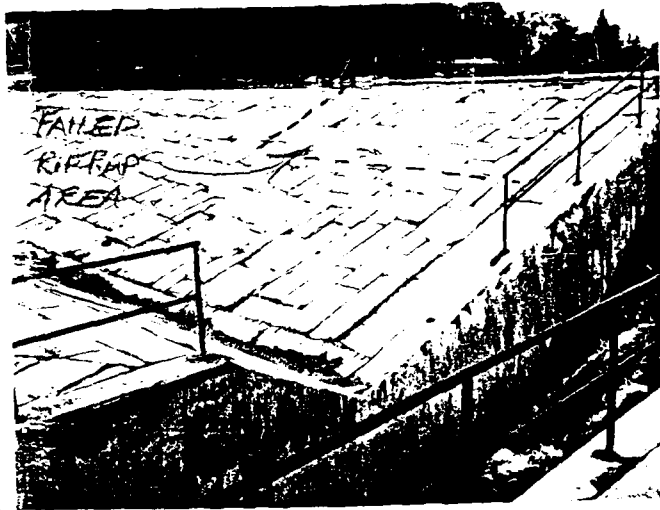
In 1970 after reconstruction of the outlet structure was completed, subsidence occurred in the emergency spillway basin (see photographs of failure in Appendix B). The emergency spillway was repaired by securing the placement of the granite blocks by grouting.

6861 MILES RD. DAM - REBAR FAILURE SEPT 30, 1970

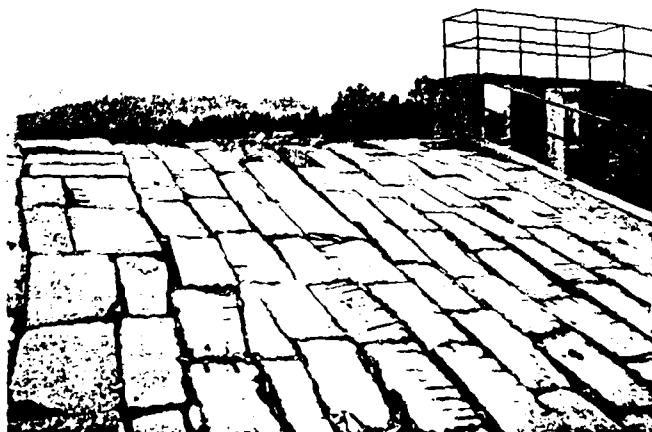
6861 MILES RD. DAM - REBAR FAILURE SEPT 30, 1970

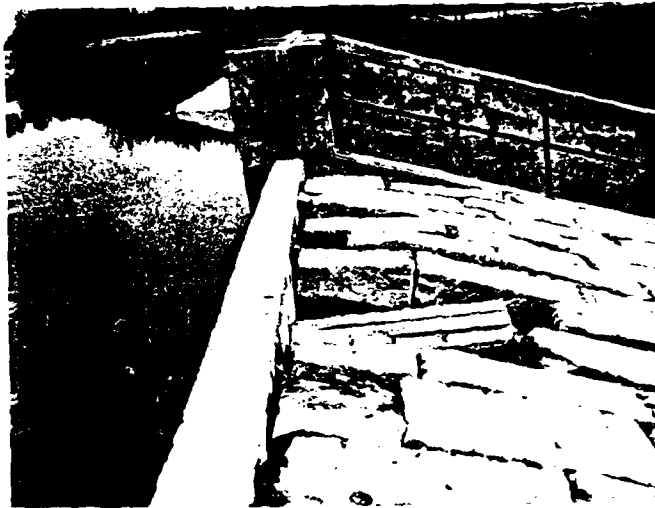
6861 Miles Pond Dam - Riprap Failure Sept 30, 1970

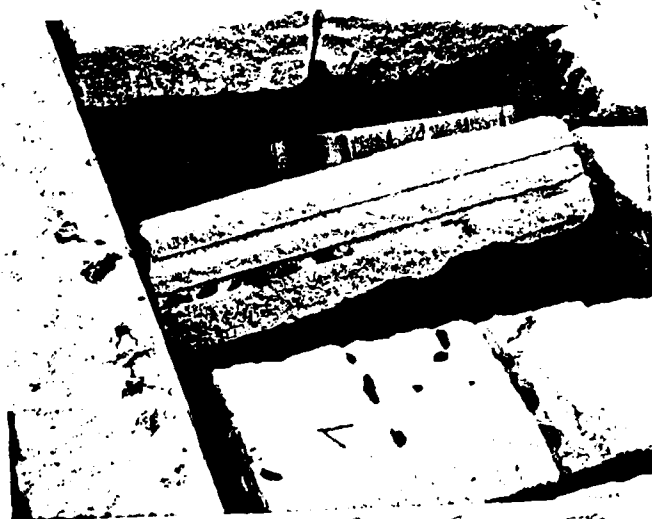
6861 Miles Pond - Riprap Failure Sept 30, 1970

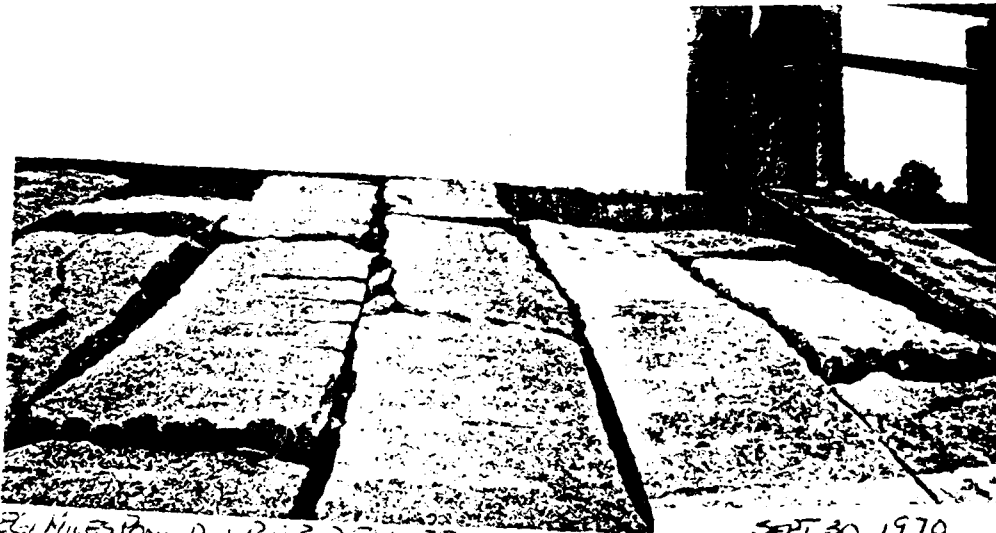
6861 MILESTON DRI R/P RAP FAILURE

SEP 30 1970

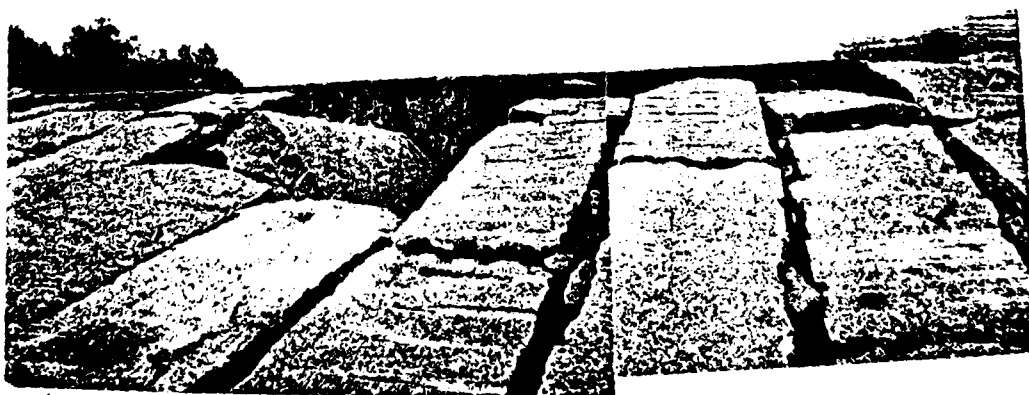
6861 MILESTON - R/P RAP FAILURE SEP 30 1970

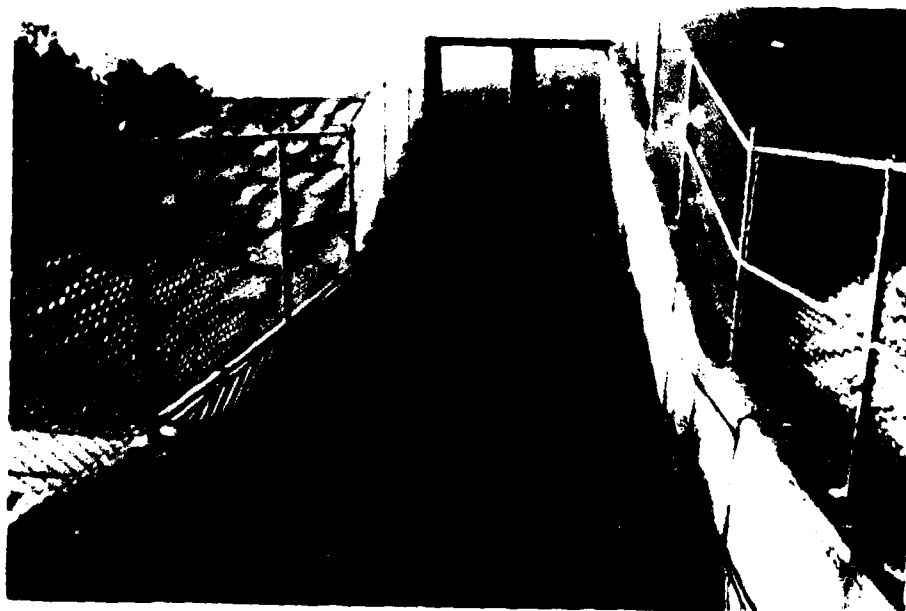
c. Appurtenant Structures. The principal spillway consists of a stop log structure, a chute spillway and concrete box culvert. The stop log structure (Photo 8) provides the entrance into the chute spillway (Photo 8) which discharges into the concrete box culvert, 6.1 by 5.2 feet (Photo 9). The condition of the concrete and stop logs of the principal spillway is good. The stop logs have straight cut edges. The discharge outlet of the principal spillway is a 280 foot long concrete box culvert. The discharge end of the spillway culvert has undergone considerable concrete erosion near the invert level (Photos 10 & 11).

#8 - Looking upstream at principal spillway (stop log chute spillway)

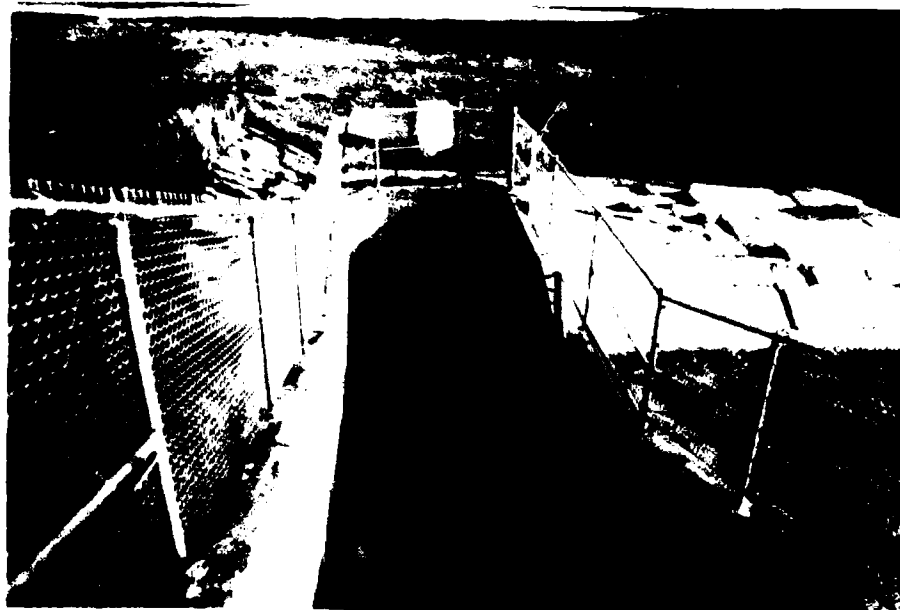
#9 - Looking downstream, from stop log structure, at the downstream end of the principal spillway (chute spillway and concrete box culvert)
